TEST REPORT NO: TRD-0031

ITEMS TESTED: TD225-104 & TDH225-104 (New design hub w/ penetrating head)

TEST PERFORMED: Torsional load test - The hubs were installed into a helical test fixture, which simulates field torque conditions. Torque was continuously applied with a D-9101-0003 wrench tube via a torsional load apparatus.

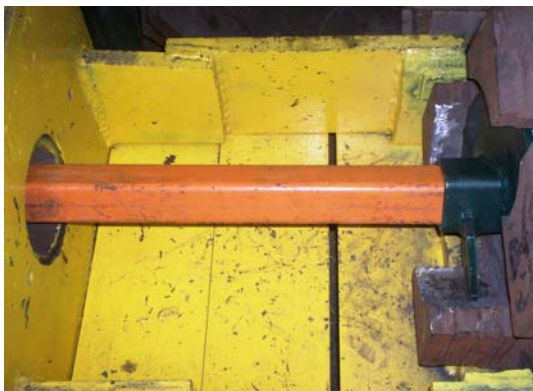
Typical set-up

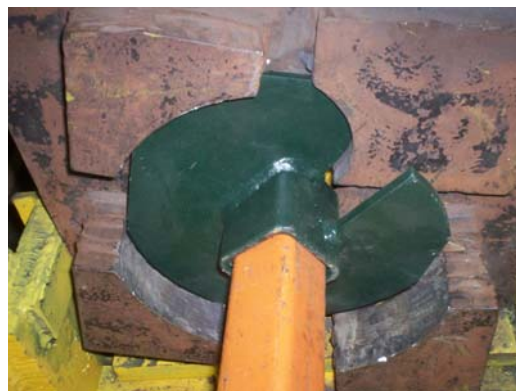
Typical set-up

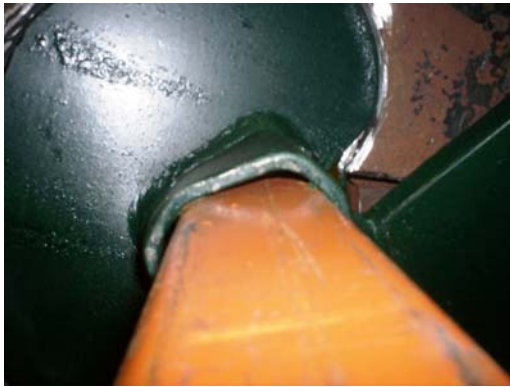
Typical failure

TD225-104 (3/8" x 10" Helix) 10,000 ft/lb rating	
Load (lb)	Failure Mode
15,786	Hub distorted due to tube rotation / no cracking occurred
14,846	Hub distorted due to tube rotation / no cracking occurred
15,535	Hub distorted due to tube rotation / no cracking occurred

TDH225-104 (1/2" x 10" Helix) 10,000 ft/lb rating	
Load (lb)	Failure Mode
17,138	Hub distorted due to tube rotation / no cracking occurred
17,184	Hub distorted due to tube rotation / no cracking occurred
17,835	Hub distorted due to tube rotation / no cracking occurred

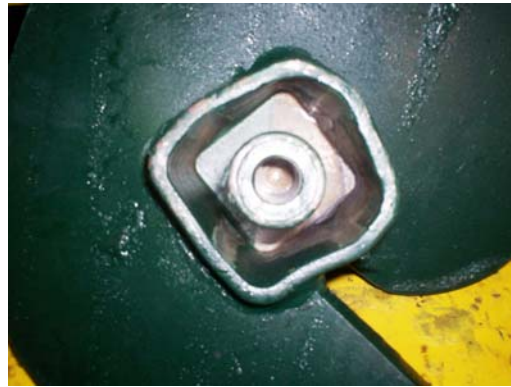
Typical failure
